व्यावसायिक परीक्षण रिपोर्ट (प्रारंभिक)
COMMERCIAL TEST REPORT (INITIAL)

संख्याNo: T-137/1539
माहMonth: September, 2023
Validity: 31.08.2030

OM ENGINEERING WORK & TRAILER OEW 5 TNE, TRAILER

Manufacturer : M/S. Om Engineering Work & trailer,
A/p. Saundane, Tal. Malegaon, Dist.
Nashik-423218, Maharashtra, India.

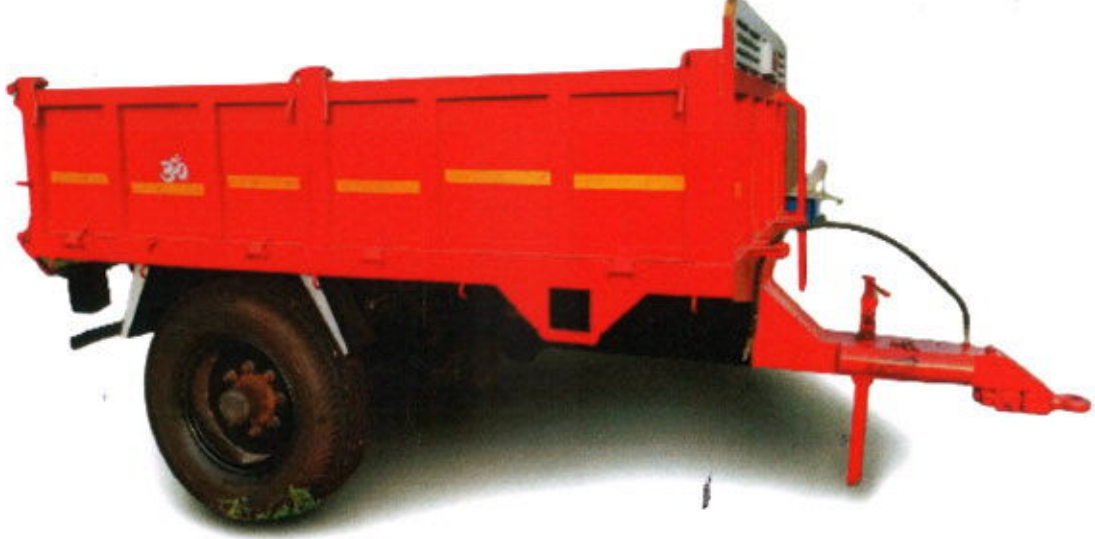
- 12.1 The specification of trailer does not conform, in full, to the IS 8213:2000 (Reaffirmed 2020). This should be looked into for corrective action.
- 12.2 Lighting arrangement for trailer is not provided as per IS 8213:2000 (Reaffirmed 2020). This should be taken care for corrective action.
- 12.3 The dimensions of hydraulic tipping cylinder do not meet, in full, to the requirement of IS 12371:1988 (Reaffirmed 2019). This should be taken care for corrective action.
- 12.4 The dimensions of ring type hitch does not meet, in full, the requirement of IS 11270:1985 (Reaffirmed 2019). This should be taken care for corrective action.
- 12.5 The dimension of various components of axle assembly does not confirm, in full, the requirement of IS 8213:2000 (Reaffirmed 2020). This should be taken care for corrective action.
- 12.6 **Adequacy of literature:**

Service manual and parts catalogues of trailer were not provided. Operation manual and parts catalogue should be brought out in Hindi and regional languages as per IS 8213:2000 (Reaffirmed 2020) for the sake of user & technical personnel.

We will do the necessary action on future lot.
